Treatment of Peri-implantitis Around TiUnite-Surface Implants Using Er:YAG Laser Microexplosions

Implant therapy can lead to peri-implantitis, and none of the methods used to treat this inflammatory response have been predictably effective. It is nearly impossible to treat infected surfaces such as TiUnite (a titanium oxide layer) that promote osteoinduction, but finding an effective way to do so is essential. Experiments were conducted to determine the optimum irradiation power for stripping away the contaminated titanium oxide layer with Er:YAG laser irradiation, the degree of implant heating as a result of Er:YAG laser irradiation, and whether osseointegration was possible after Er:YAG laser microexplosions were used to strip a layer from the surface of implants placed in beagle dogs. The Er:YAG laser was effective at removing an even layer of titanium oxide, and the use of water spray limited heating of the irradiated implant, thus protecting the surrounding bone tissue from heat damage. Peri-implantitis can be effectively treated using Er:YAG laser irradiation. (Int J Periodontics Restorative Dent 2013;33:21–29. doi: 10.11607/prd.1593)

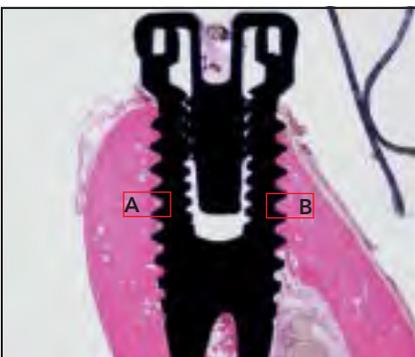
Fig 5a Histologic sample 6 weeks after implantation.

filled in approximately one-third of the gap (Fig 4c). Figures 5a to 5c show an implant after 6 weeks at 10× and 200× magnifications. Bone formation can be observed on both the nonirradiated (Fig 5b) and irradiated surfaces (Fig 5c).

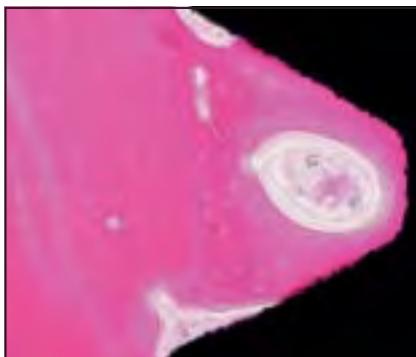
Figs 5b and 5c Bone growth can be observed on both (b) nonirradiated (magnified view of highlighted area A in Fig 5a) and (c) Er:YAG laser-irradiated surfaces (magnified view of highlighted area B in Fig 5a). Thus, osseointegration is possible for the Er:YAG laser-stripped surface (original magnification $\times 200$).

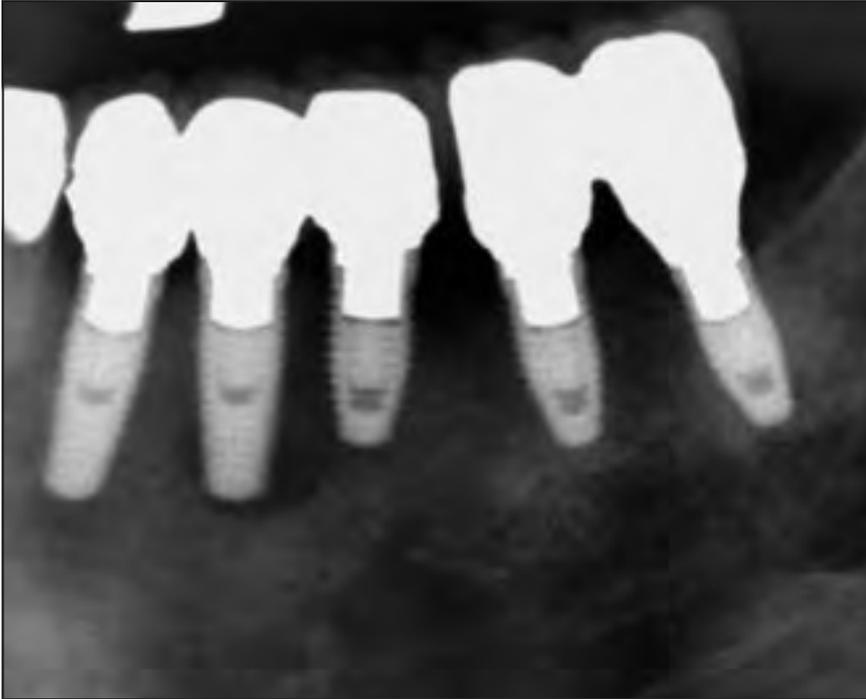
Fig 6 Radiograph showing considerable bone loss around the implants in the mandibular left posterior quadrant.

In September 2006, an 81-year-old woman received a total of nine implants, five of which are shown in Fig 6: the mandibular left canine site, first and second premolar, and first and second molar. After 4 months, provisional restorations were placed, and 6 months later, the definitive restorations were delivered. After 1 year, the patient complained of swelling around her implants. Radiographic examination showed considerable resorption around the implants in the region of the mandibular left posterior quadrant (Fig 6). The superstructure was removed, and it was

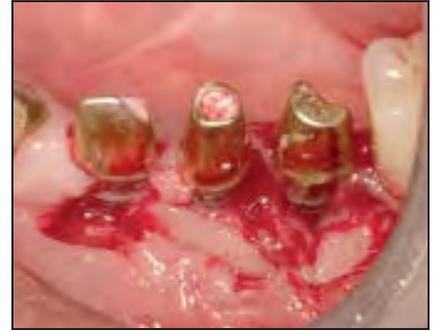
Fig 7 After raising a buccal flap, a large amount of inflamed granulation tissue was removed using the Er:YAG laser.

erable bone resorption and granulation tissue were found (Fig 7). The infected granulation tissue was ablated and removed by laser irradiation using a PS600T tip at 50 mJ power and 20 PPS with a 5-mL/min sterilized water spray (Figs 8a and 8b). Granulation tissue is normally removed using a curette, but the resultant bleeding prevents a clear view of the treatment area. The Er:YAG laser with water spray eliminates this problem. The application of water spray and the microexplosions caused by the laser light hitting the water maintain visibility in the treatment area (Fig 9).

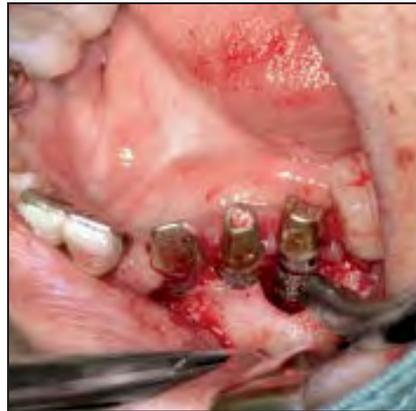
Figs 8a and 8b The key to removing contaminated granulation tissue with an Er:YAG laser is to irradiate not the granulation tissue itself but the layer where the granulation tissue and healthy bone tissue meet. In this way, the contaminated granulation tissue can be removed in a single mass. After removing the granulation tissue, the contaminated TiUnite surface layer was stripped away and sterilized.

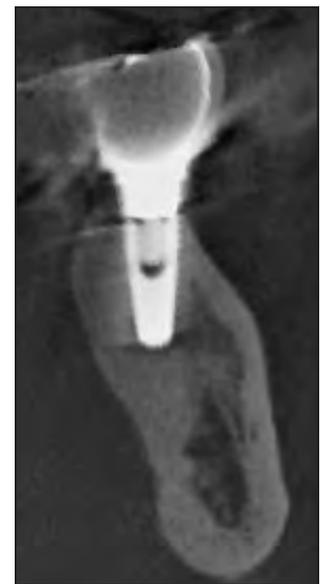
Fig 11 Computed tomography scan 4 years after treatment. The peri-implantitis had been resolved, and the area around the implant had stabilized.

showed apparent bone regeneration. A computed tomography scan (buccolingual cross section) was obtained 4 years after treatment (Fig 11). The area around the implant had stabilized.
